Hurricane *Dorian* - Preliminary Assessment for Bogue Banks Oceanfront (9/6/19)

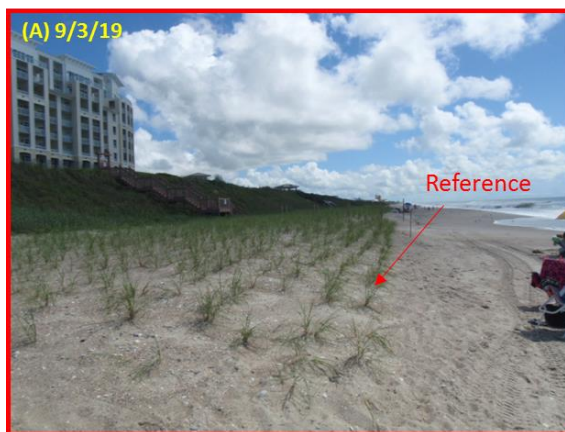
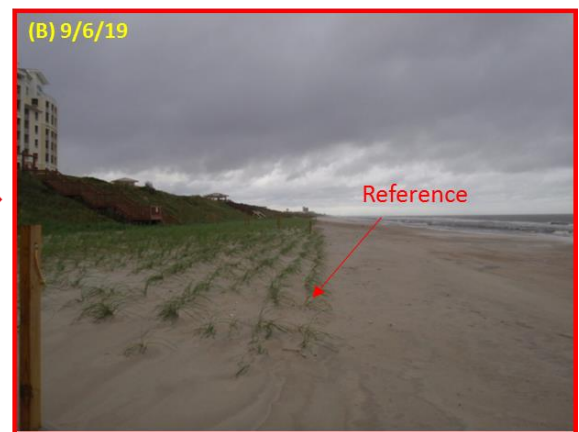
- (1) **No significant dune erosion** along the entire ~25 mile long Bogue Banks oceanfront. Most sand fencing and posts at the base of the dune were not damaged as well.

- (2) The Post-*Florence* Beach Nourishment Project ([Phase I](#)) was completed just over 4 months ago, which included a dune feature and placed 945,446 cubic yards of sand along eastern Emerald Isle and Indian Beach/Salter Path (5.2 miles). Additionally, +350,000 sea oats were planted along the dune crest (flat top of dune) and the dune slope – **there was very little damage to the dune plants** from *Dorian*.

BEFORE

AFTER

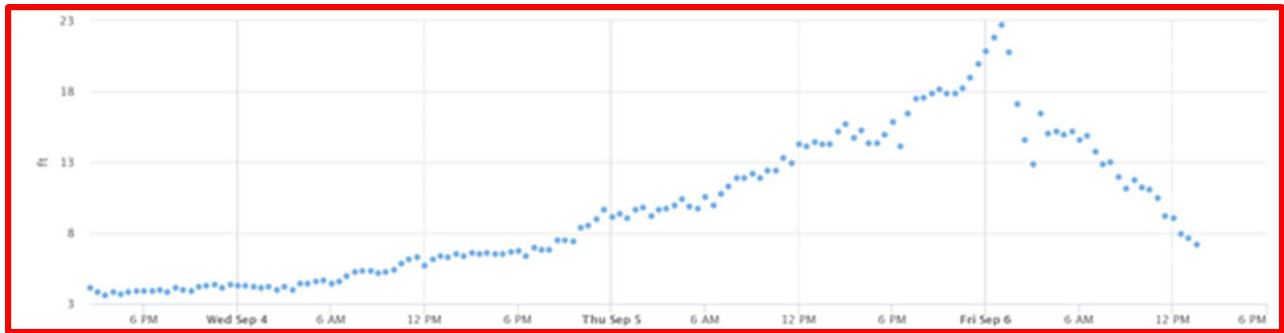
Offshore Waves, Storm Tide – The nearest wave buoy is located roughly 40 miles due south of Beaufort Inlet ([LEJ3](#)) and recorded a wave height of 23 feet on early Friday morning (9/6/19) as *Dorian* swept south of Bogue Banks (image below). The maximum wave height for the last

hurricane significantly impacting Bogue Banks was 28 feet (*Florence* 2018). *Florence*'s duration in Onslow Bay was much longer and the approach was from a different angle.
