Bogue Banks Beach and Nearshore Mapping Program

November 2015

Executive Summary

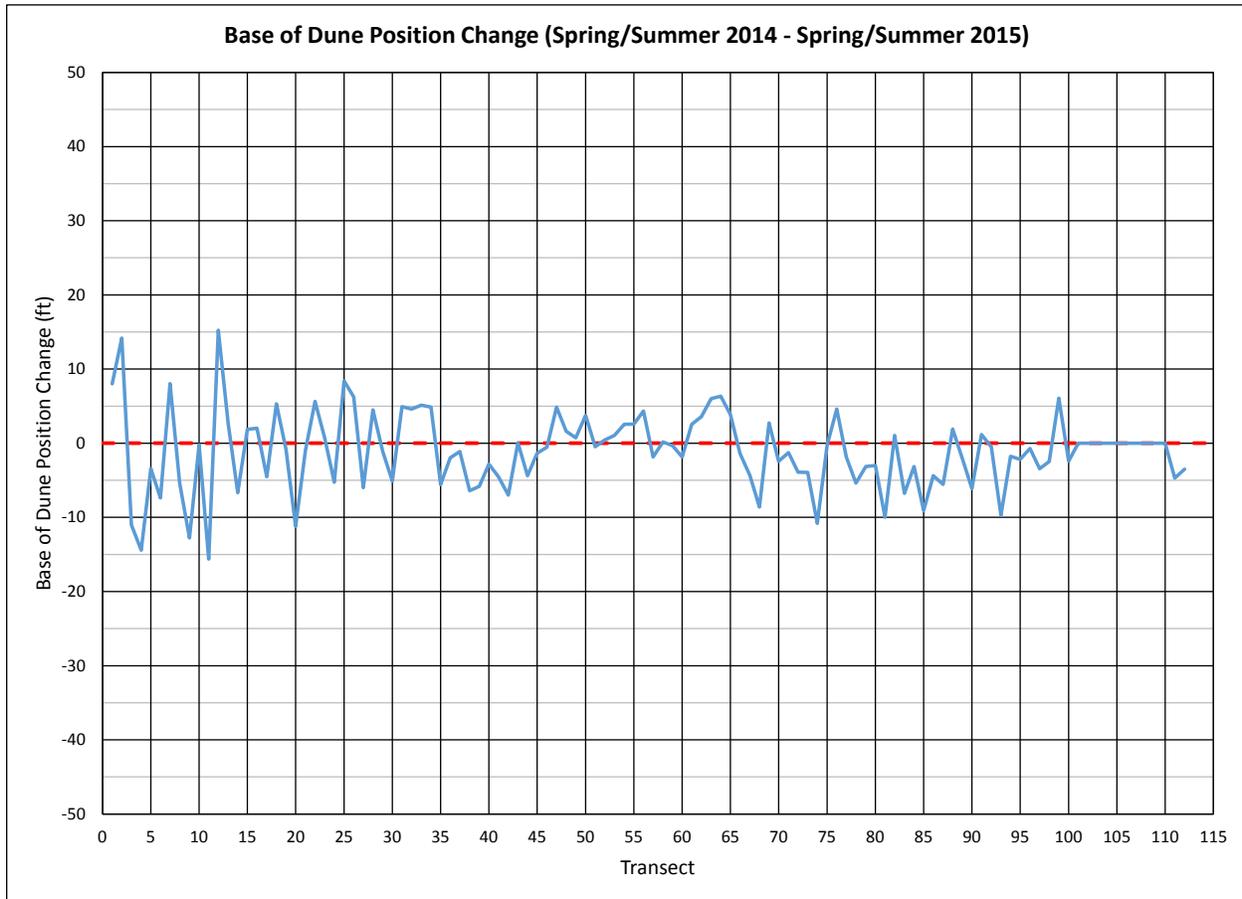
This year’s analysis also included an assessment of the change in position of the base of the dune along Bogue Banks, which was performed using shore parallel survey lines collected in 2014 and 2015 by driving the survey ATV along the base of the dune. The difference in position at each transect was calculated and plotted to determine any trends in movement along the oceanfront shoreline. **Figure 5-7** presents the results of this analysis. An average landward movement of

approximately 1.1 ft was calculated over the entire shoreline. It should be noted that the accuracy of the dune base position surveyed is highly subject to surveyor interpretation. Other methods for tracking this feature are being investigated.

Figure 5-7. Base of Dune Position Change

This year's analysis also included an assessment of the change in position of the base of the dune along Bogue Banks, performed using shore parallel survey lines collected in 2014 and 2015. The difference in position at each transect was calculated and plotted to determine any trends in dune base movement along the oceanfront shoreline. An average landward movement of approximately 1.1 ft was calculated over the entire shoreline. It should be noted that the accuracy of the dune base position survey is highly subject to surveyor interpretation and other methods for tracking this feature are being investigated.

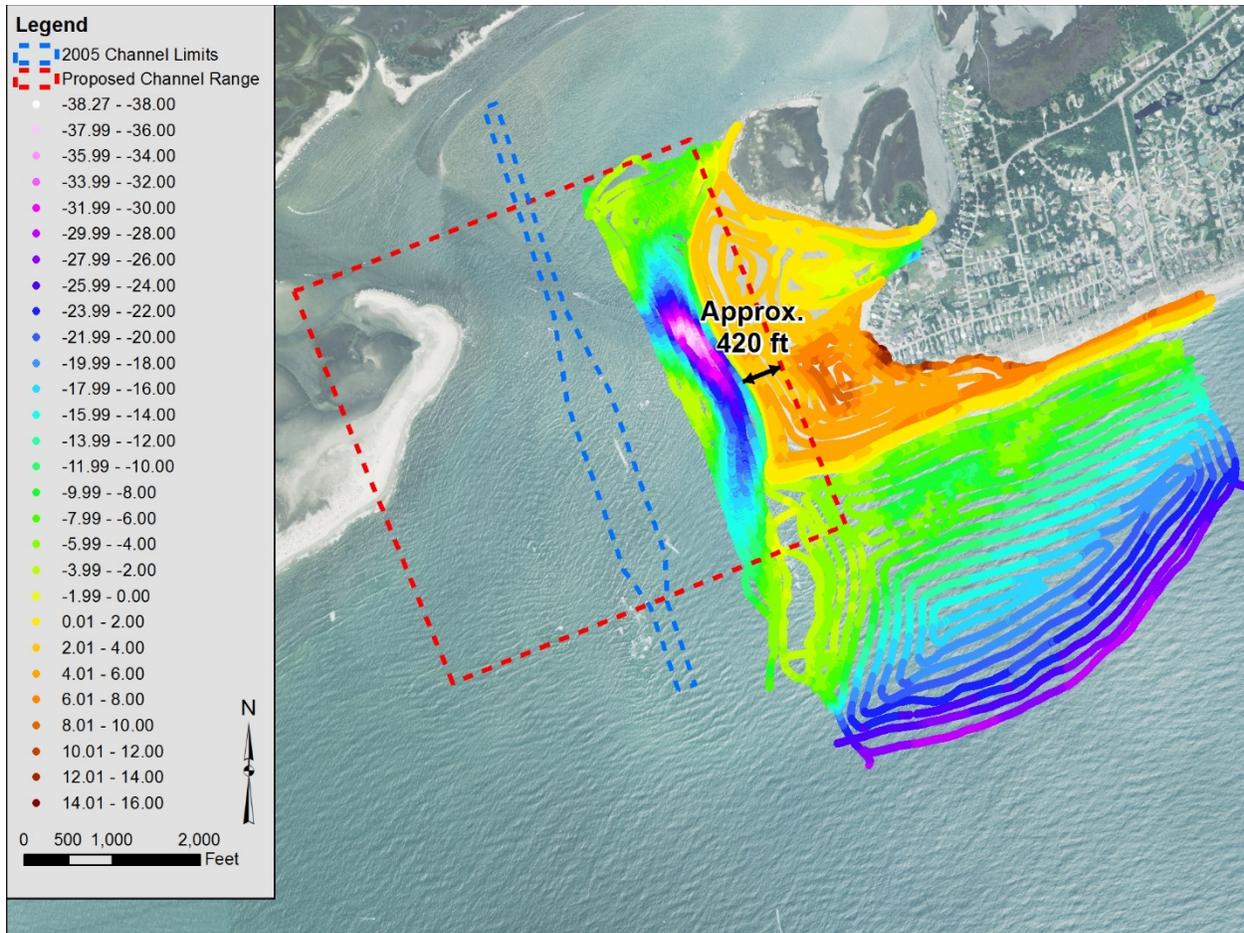
The Bogue Inlet-Channel region is highly dynamic due to the inlet. The location of dry land changes so frequently that profiles along Bogue Inlet often do not line up properly from year to year. Therefore, analytical calculations were not performed at Transect 117 through 120. However, upon investigation of the profile plots in **Appendix C**, it appears that there has been some erosion at the mouth of the inlet at Transects 117B and 117 which was captured in the spit at Transect 118. Transects 119 and 120 show some eastward migration of Bogue Inlet channel.

In June 2015, Geodynamics conducted a topographic and hydrographic survey to assess conditions at the Point. Based on this survey, it appears that approximately 420 ft exist between the edge of the current channel location and the boundary of the “safe box” which was determined as part of the Master Beach Nourishment Plan (see **Figure 5-17**). When compared with a similar survey taken in April 2014, the channel appears to have moved approximately 30 ft to the east between April 2014 and June 2015.

Figure 5-17. Bogue Inlet Channel Survey

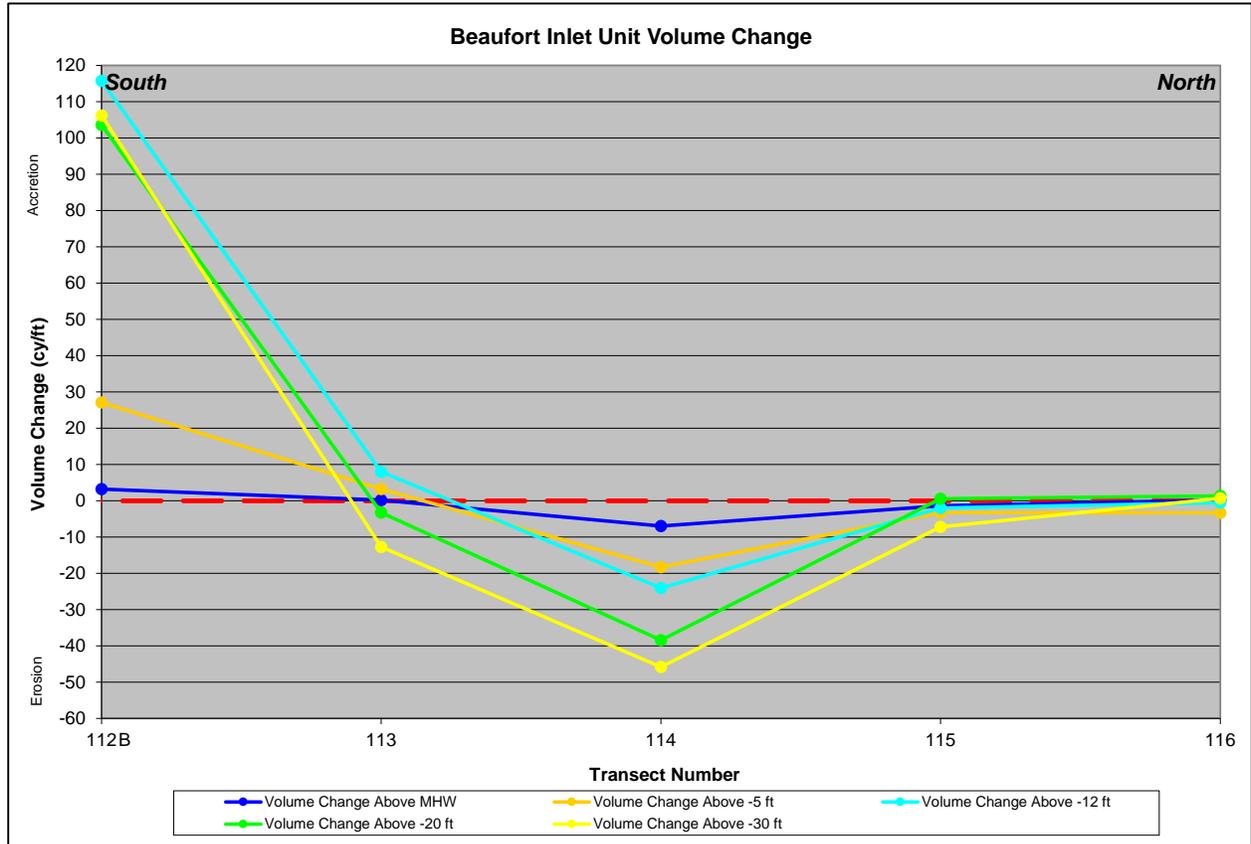
Volume changes at Beaufort Inlet fluctuate between minor gains and losses above the different elevations. Transect 112B deviates from this trend as it experienced some large offshore changes,

however the rest of the reach remained fairly stable. **Figure 5-18** displays the unit volume change at each transect in the Beaufort Inlet region.

Figure 5-18. Beaufort Inlet Unit Volume Change (2014 - 2015)

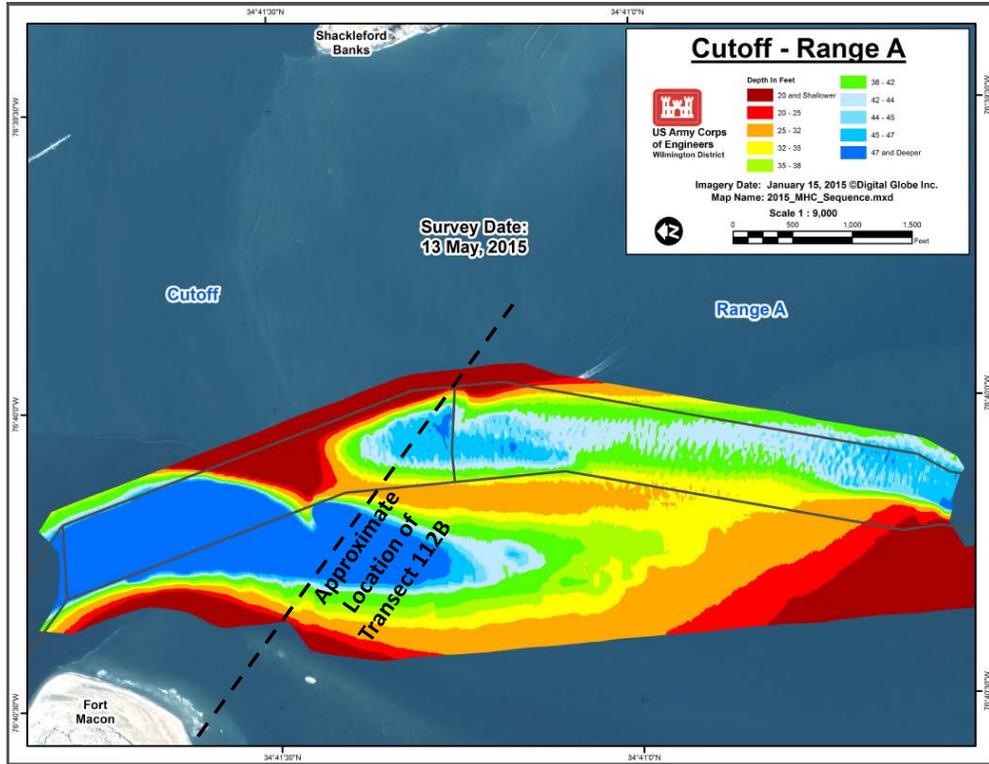
In May 2015, the USACE performed a condition survey of the Morehead City Harbor navigation channel. **Figure 5-19** presents the results of the survey. Apparent from this figure is the submerged “toe” of Shackleford Banks along the eastern side of the channel. Also of importance is a more shallow feature cutting through the middle of the stretches of deep water. This feature was also detected in the profile plot of Transect 112B (at approximately 3,000 ft offshore) along with another shallow feature approximately 1,300 ft offshore as shown in **Figure 5-20**.

Figure 5-19. USACE Morehead City Harbor Navigation Channel Survey - May 2015 (USACE)

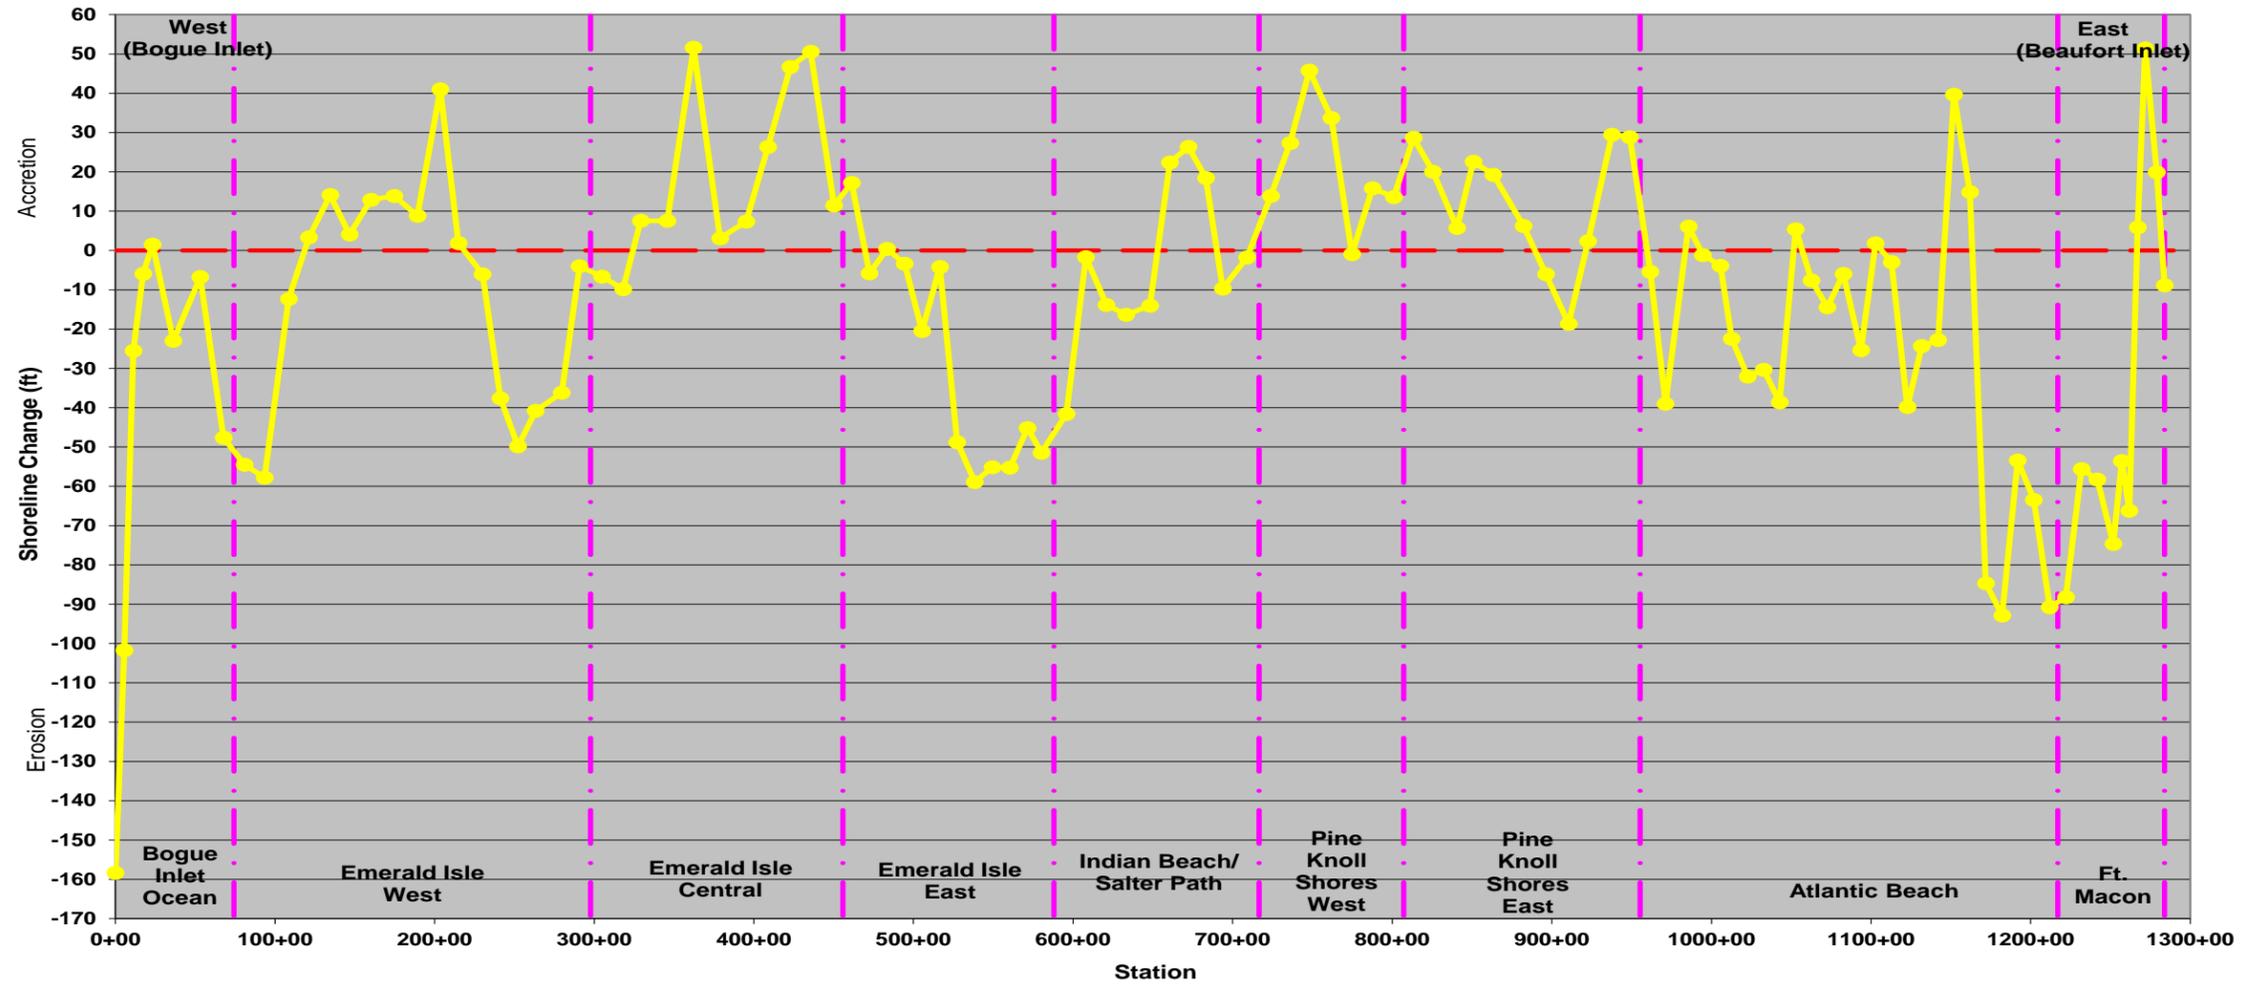
Figure B-1. Shoreline Change for Bogue Banks (Spring/Summer 2014 – Spring/Summer 2015)

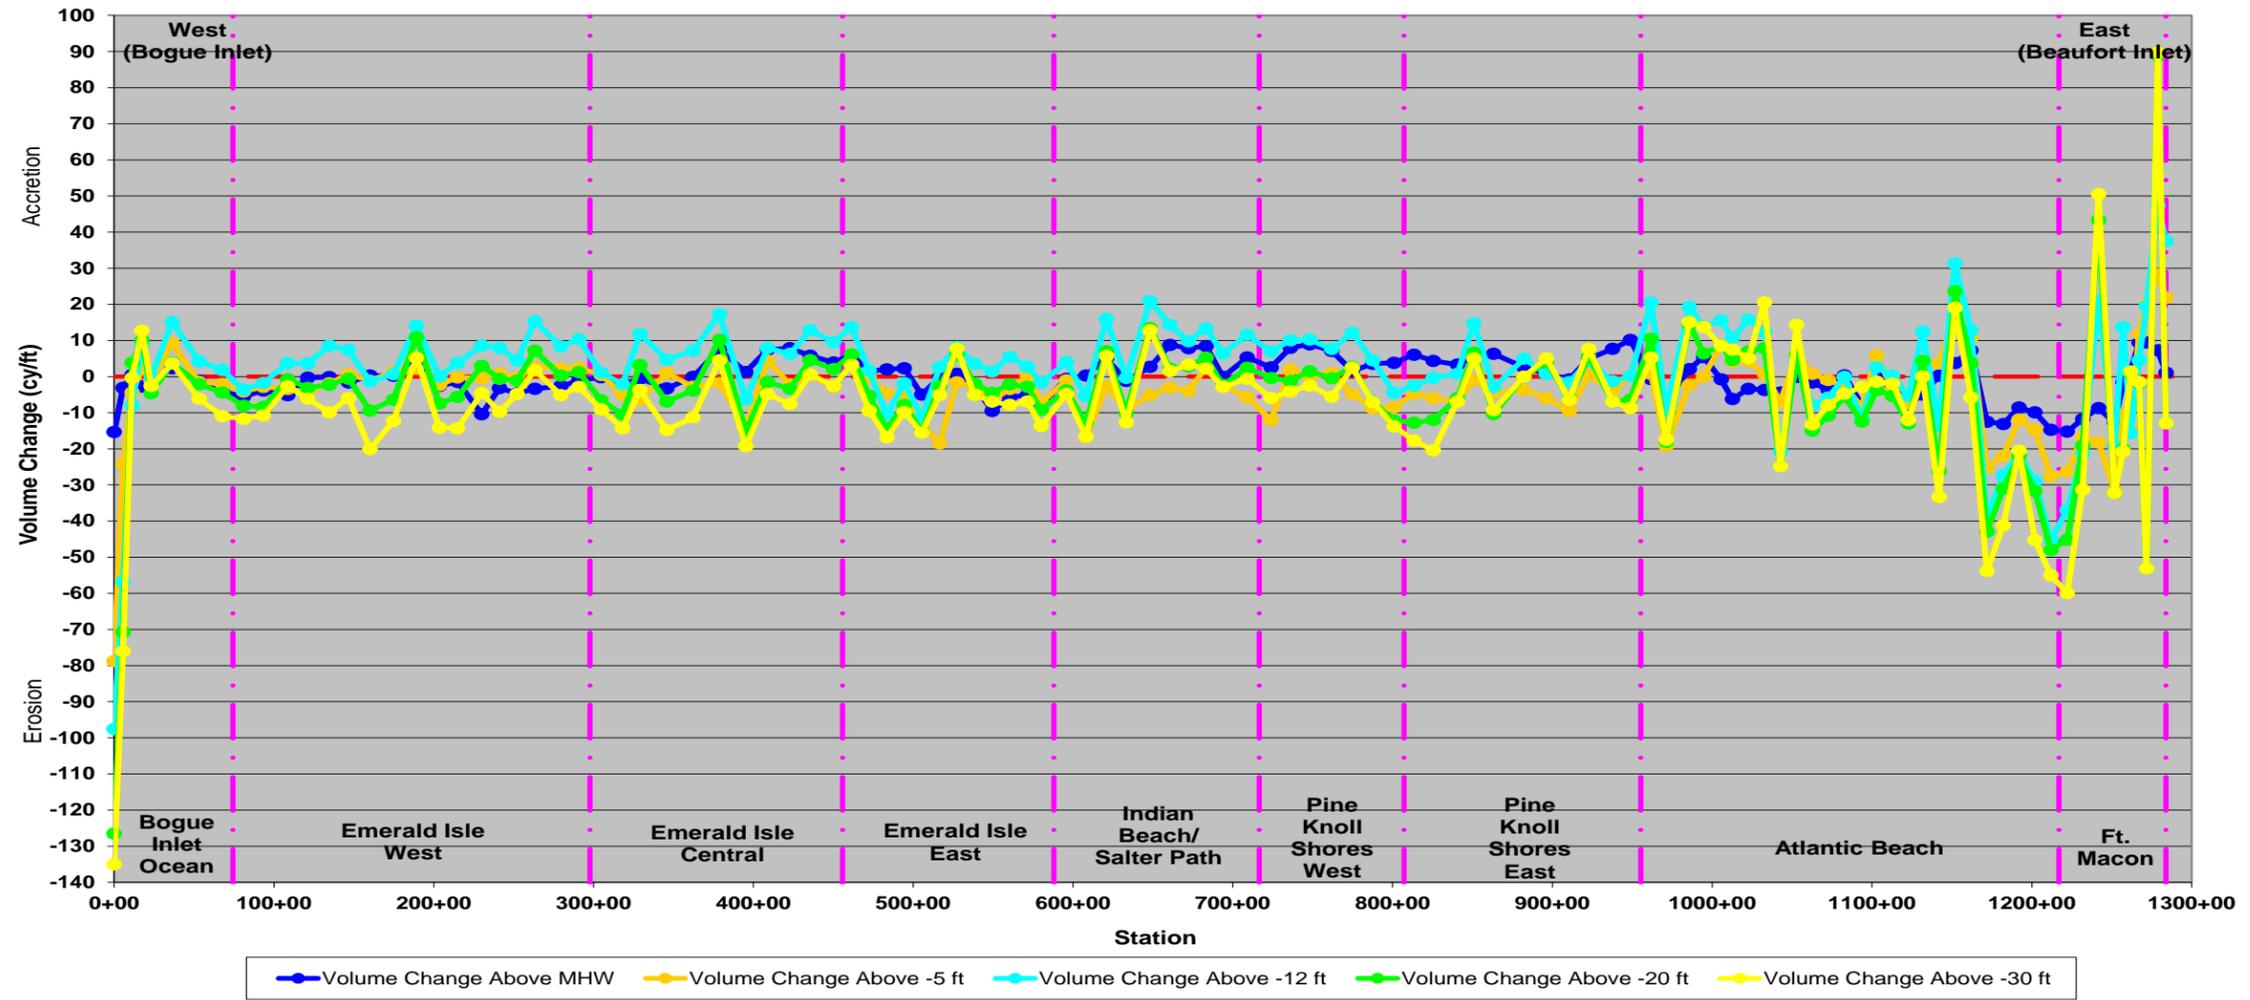
Figure B-2. Volume Change for Bogue Banks (Spring/Summer 2014 - Spring/Summer 2015)

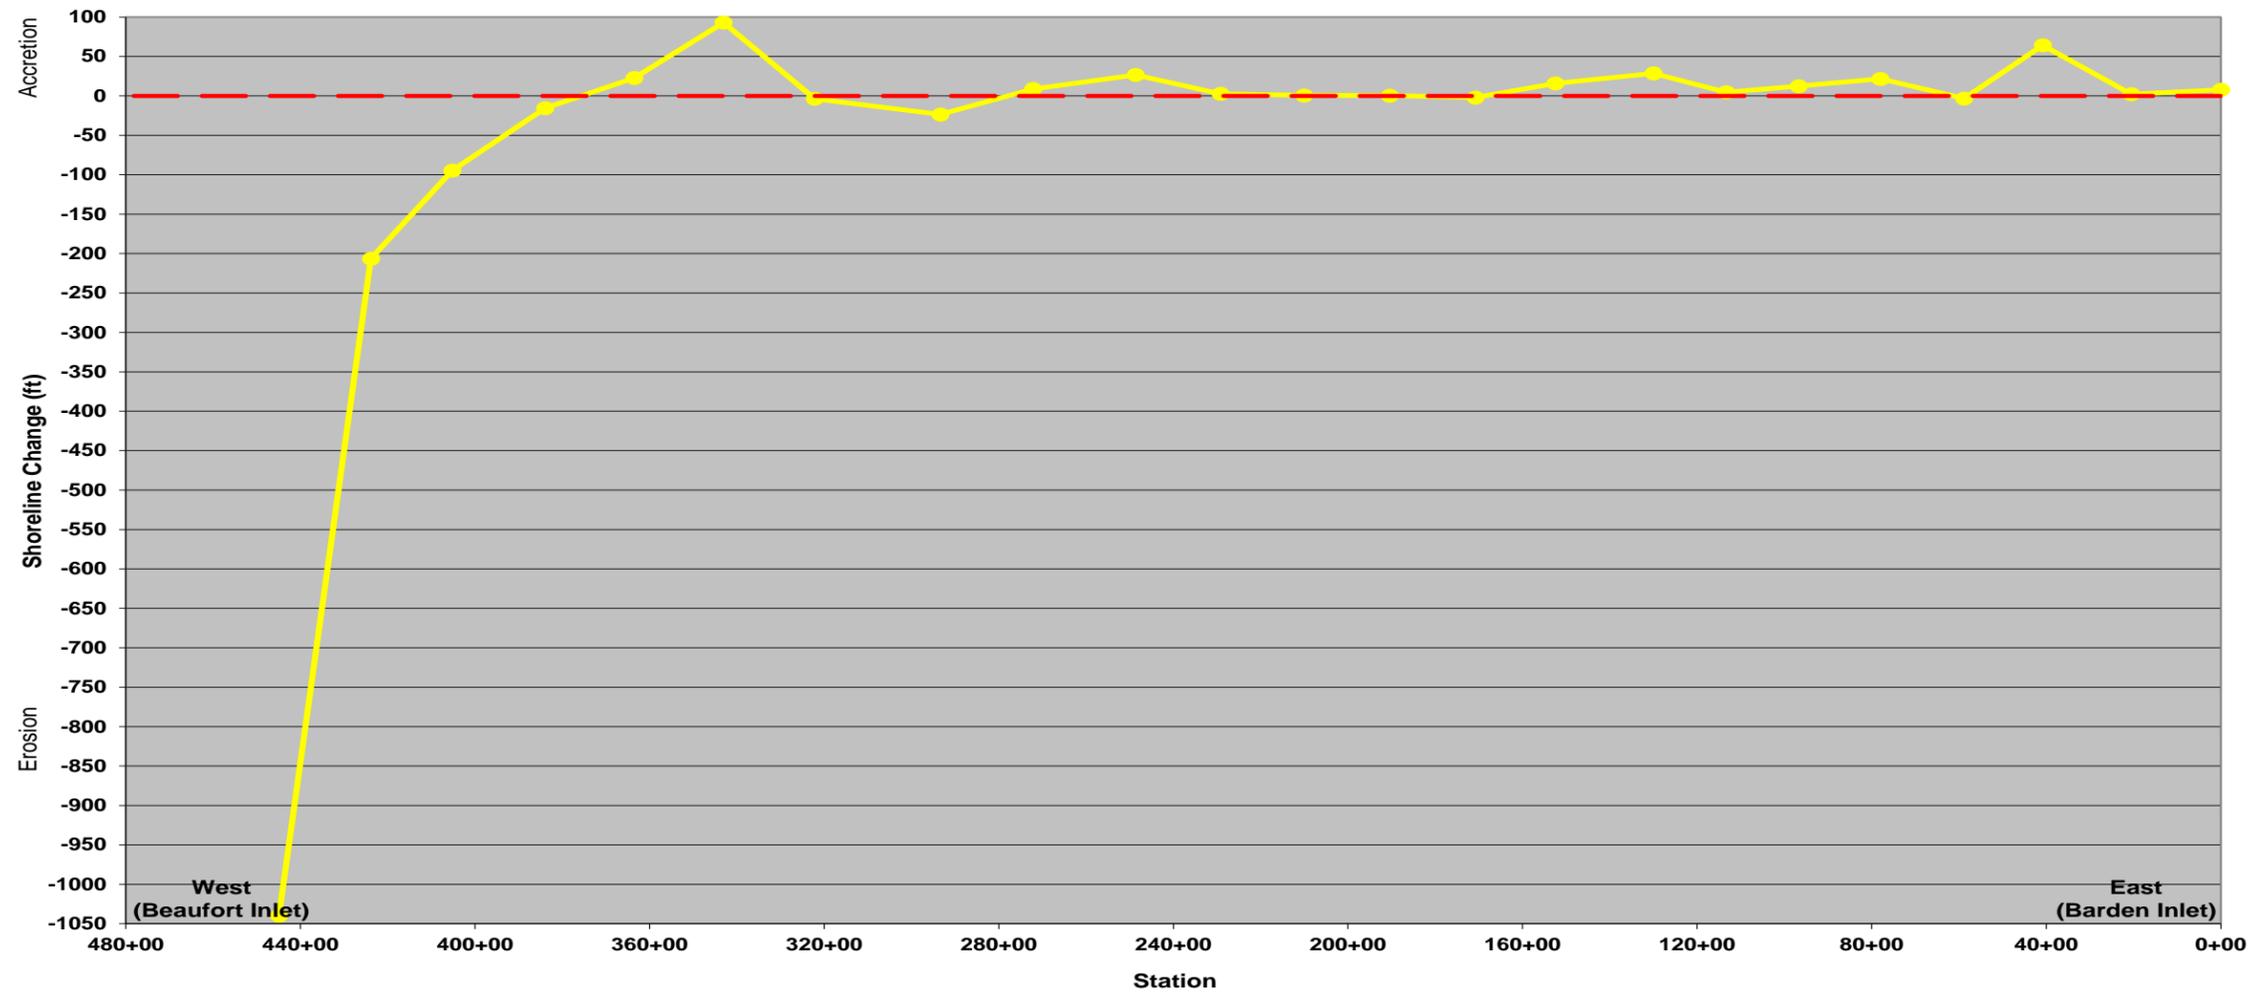
Figure B-5. Shoreline Change for Shackleford Banks (Spring/Summer 2014 - Spring/Summer 2015)

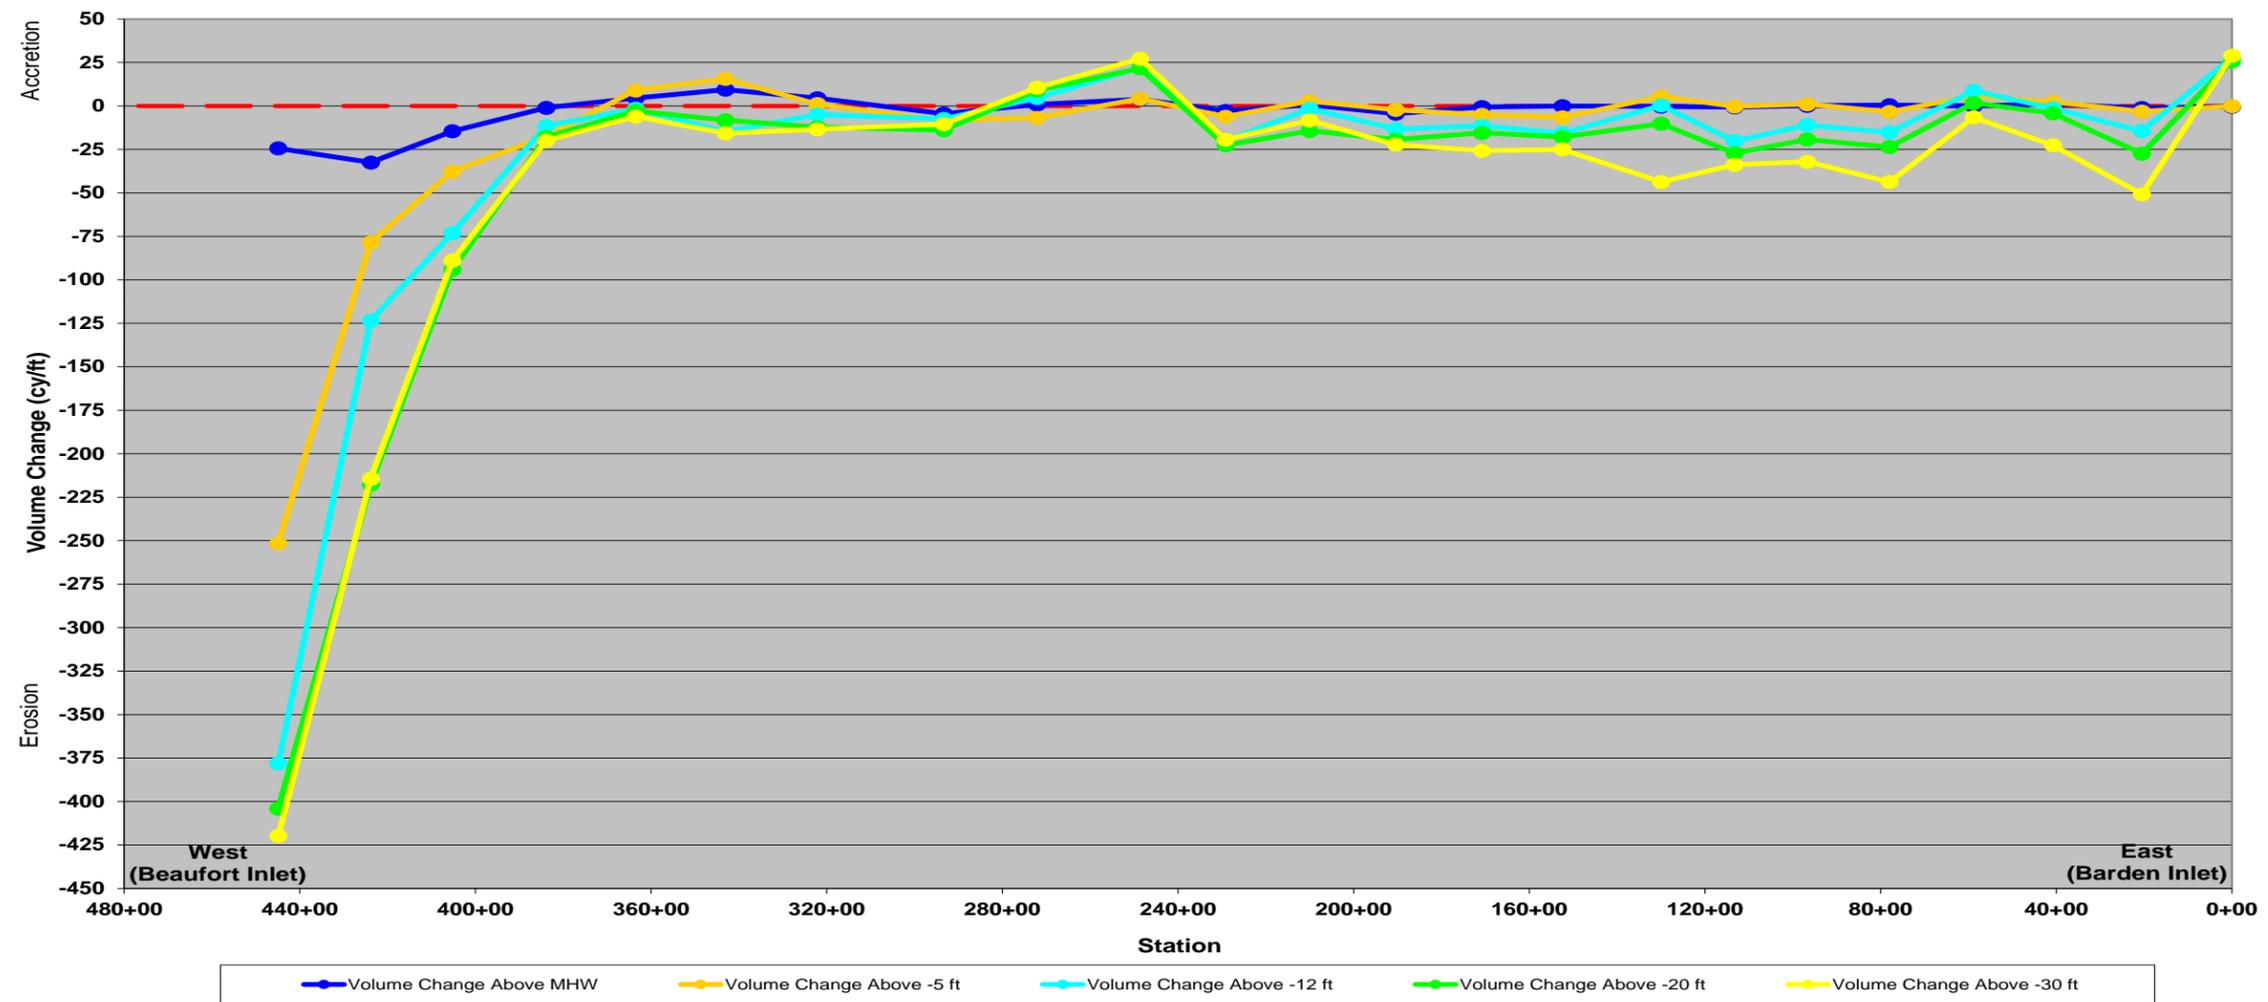
Figure B-6. Volume Change for Shackleford Banks (Spring/Summer 2014 - Spring/Summer 2015)
