Bogue Banks Beach and Nearshore Mapping Program

September 2012

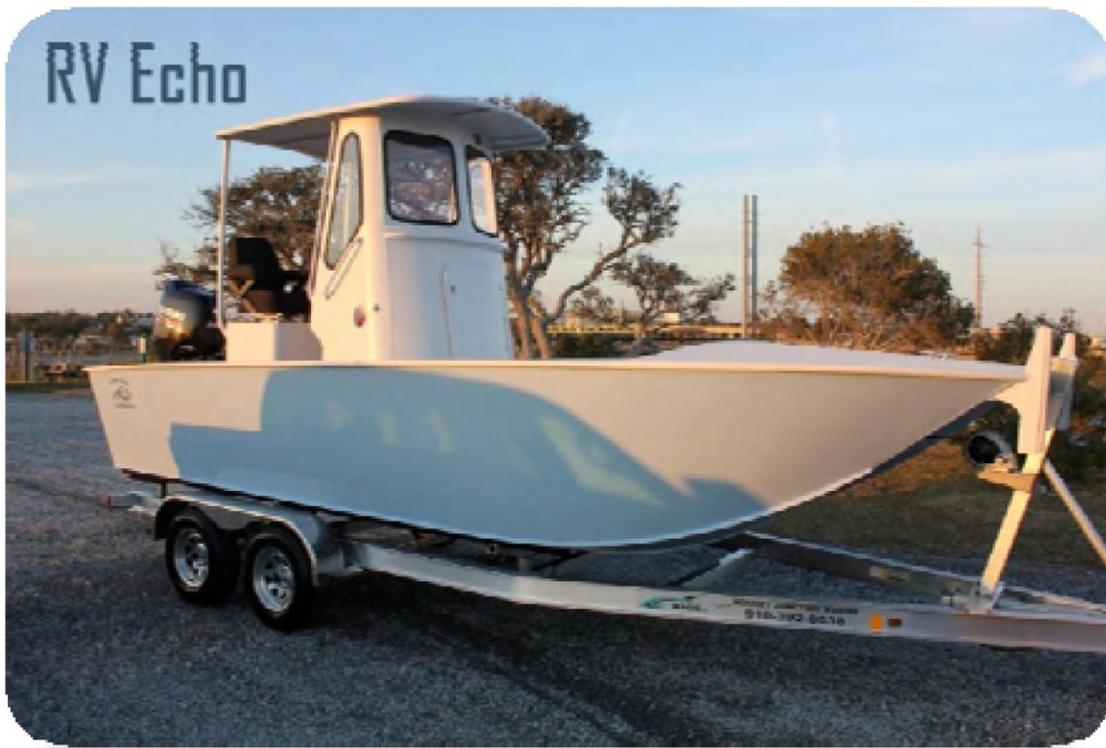
The R/V Echo served as the survey platform for singlebeam data acquisition (**Figure 3**). The R/V Echo is designed to be a vessel of opportunity for shallow water inshore and coastal ocean mapping. The R/V Echo is a 21 ft Cape Fear Catamaran with through-hull and pole-mount singlebeam sonar capability. The vessel is powered by a 140 hp four-stroke engine mounted on a jack plate to enable ultra shallow water data collection. Data acquisition computers are housed within the water-tight console and are powered through an onboard battery bank. This vessel represents the state-of-the-art in modern hydrographic surveying. The hardware systems inventory for the R/V Echo is shown in **Table 3**.

Figure 3. The R/V Echo Hydrographic Survey Platform Setup
