# 2005 Sea Turtle Monitoring Project Report Bogue Banks, North Carolina

## INTERIM REPORT

Kristin T. Holloman & Matthew H. Godfrey  
North Carolina Wildlife Resources Commission  
February 2006

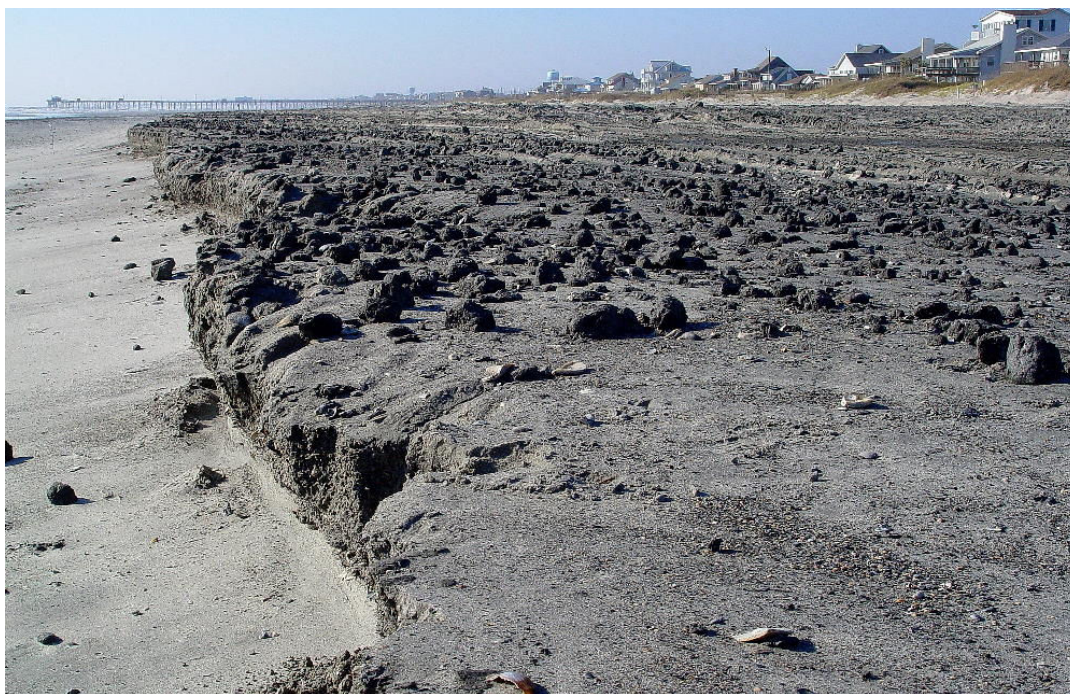
Figure 1. Heavy mud content in material placed on Atlantic Beach during 2004/2005 nourishment project.

The majority of nests were laid in Pine Knoll Shores and Emerald Isle (Table 2). Hatchling emergence success was reduced in 2005 relative to 2004, primarily due to egg loss associated with Hurricane Ophelia: 11 nests were either washed away or severely flooded in September 2005. Nests in Atlantic Beach were laid in a nourished area that was high in mud content that contributed to the reduced hatchling emergence success (Figure 1, Appendix I).

Regardless of the total compaction scores of the different nests, most nests were successful in producing viable hatchlings. The primary cause of nest failure was inundation due to storm surge. However, the three nests laid in Atlantic Beach appeared to have been affected by the heavy muddy sediment in which they were incubating – this sediment was placed on the beach during the nourishment project in early 2005 (Appendix I).

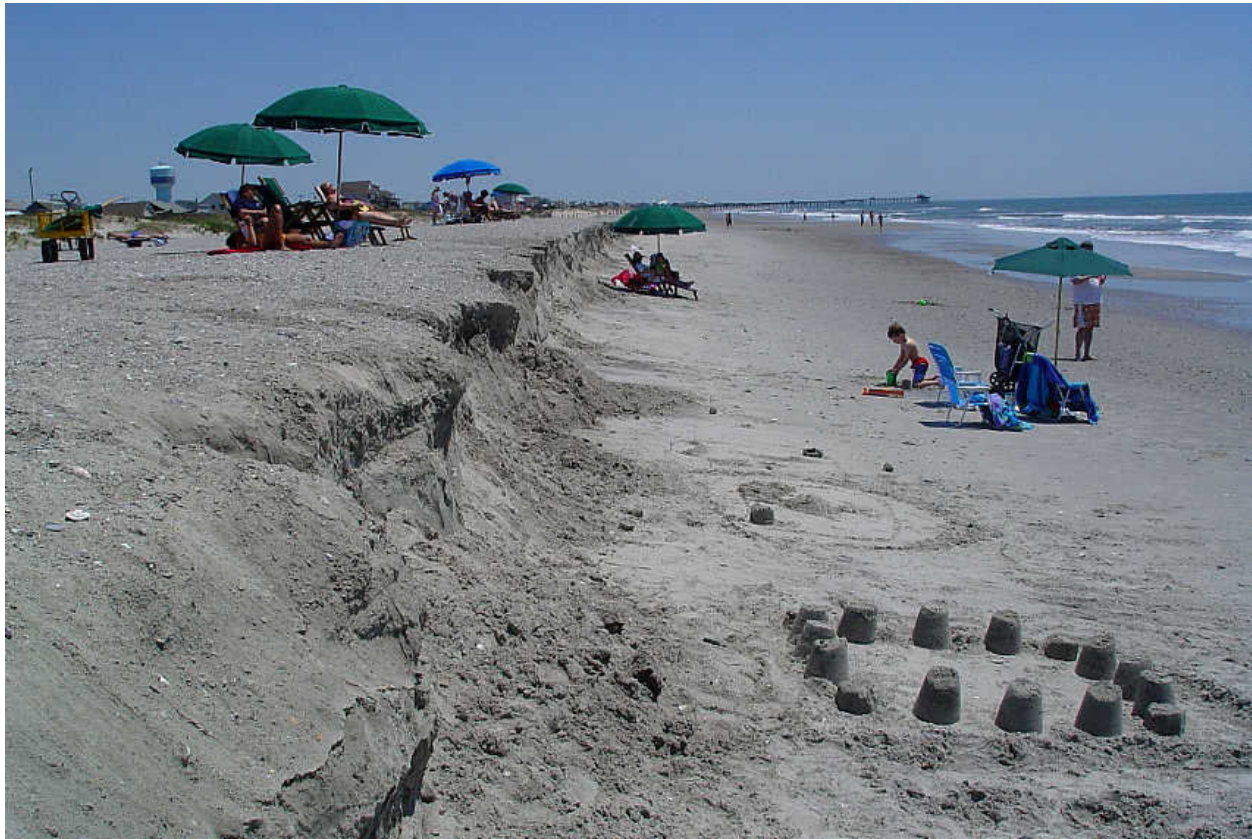
Figure 8: Steep escarpment on Atlantic Beach in May 2005.

Another effect of the 2005 nourishment project in Atlantic Beach was the post-project formation of severe escarpments (some reaching >2 meters) just above the swash zone several hundred meters to the west of Atlantic Beach Circle (Figure 8). Consultation among NC Wildlife Resources Commission, Atlantic Beach Public Works and the US Army Corps of Engineers resulted in limited bulldozing to level the escarpments to approximately 45° angle in June. This action made it possible for turtles to crawl up the beach in this area and also reduced the possibility of accidental injury to beach visitors.
